A COMPARATIVE EVALUATION OF THREE POTENTIAL
ICE RESCUE VEHICLES

BY: LTJG JOHN A. BUDDE, USCGR

SEPTEMBER 1982

FINAL REPORT

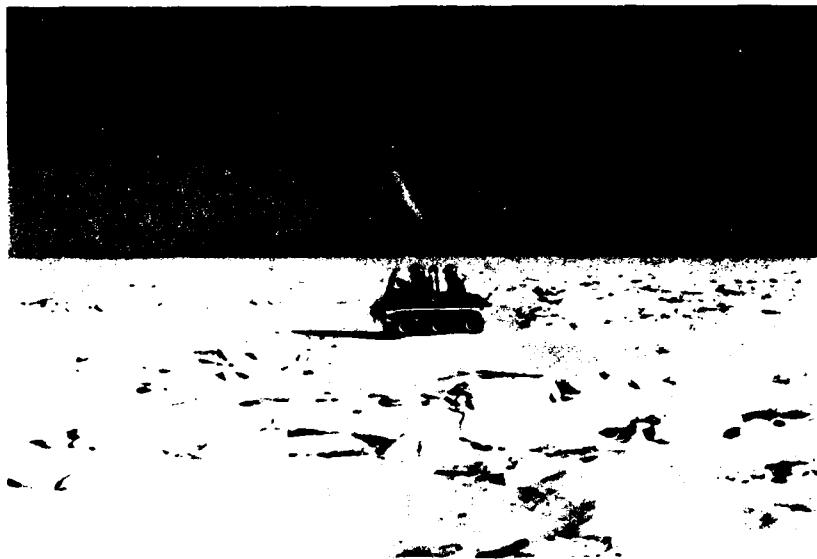
a. The ATV negotiating the windrows.

Figure 5.2 Both the ATV and the Airboat completed the initial trials without difficulty.

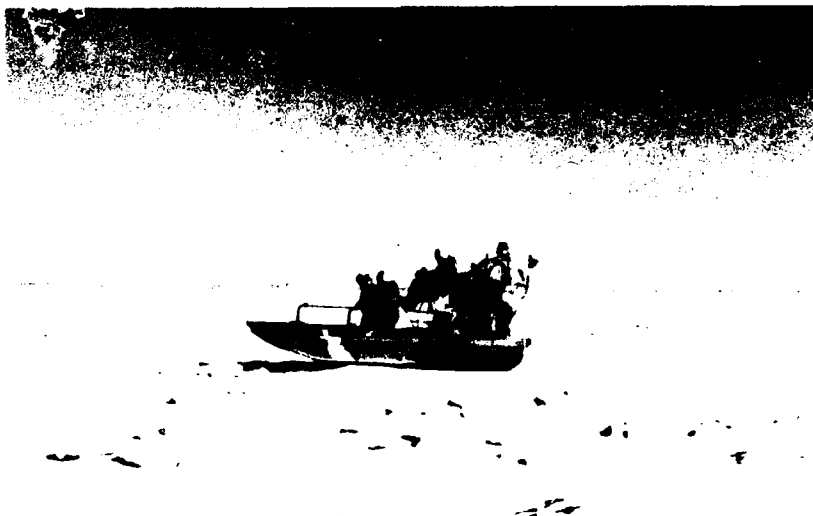
b. Airboat negotiating the windrows.
